PL-TR-91-2191 (II)

THE DESIGN, DEVELOPMENT AND TEST OF BALLOONBORNE
AND GROUNDBASED LIDAR SYSTEMS
Volume 2: Flight Test of Atmospheric Balloon
Lidar Experiment, ABLE II

Visidyne, Inc
10 Corporate Place
South Bedford Street
Burlington, MA 01803

Final Report
30 May 1986-31 December 1990

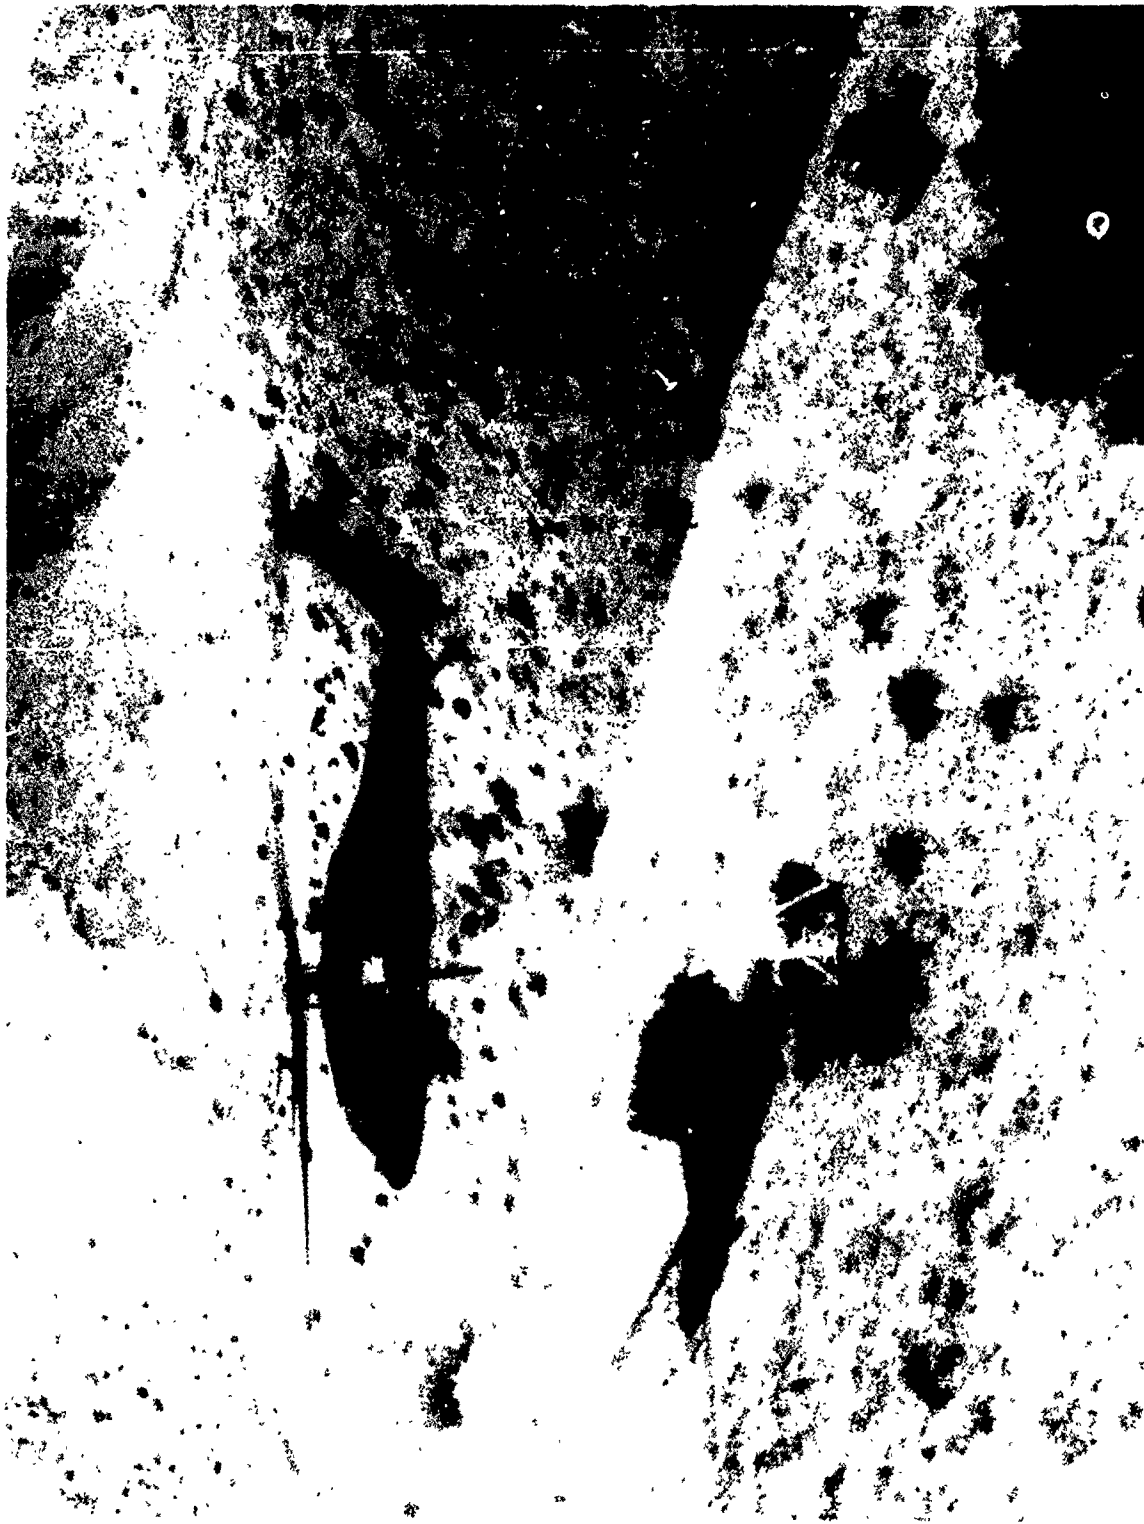
Figure 25. Recovery of the ALE II payload by Black Hawk helicopter.

The next morning on 1 September 1987, two helicopters, another Iroquois and a VH-60 Black Hawk, met the recovery crew at the RAD site. The Iroquois airlifted the crew into the landing spot from where they hiked in and secured the payload for lifting. Then the Black Hawk helicopter, which has a lift capacity of up to 8000 lb^[5], lifted the payload (Fig. 25) to the nearest road where it was loaded onto a truck (Fig. 26) for shipment back to Bldg. 850 at Holloman, AFB.
